# Maryland Historical Trust

## State Historic Sites Inventory Form

and/or common Windolph/Williams Farm

street & number 16420 Darnestown Road not for publicationcity, town Dawsonville X vicinity of congressional district

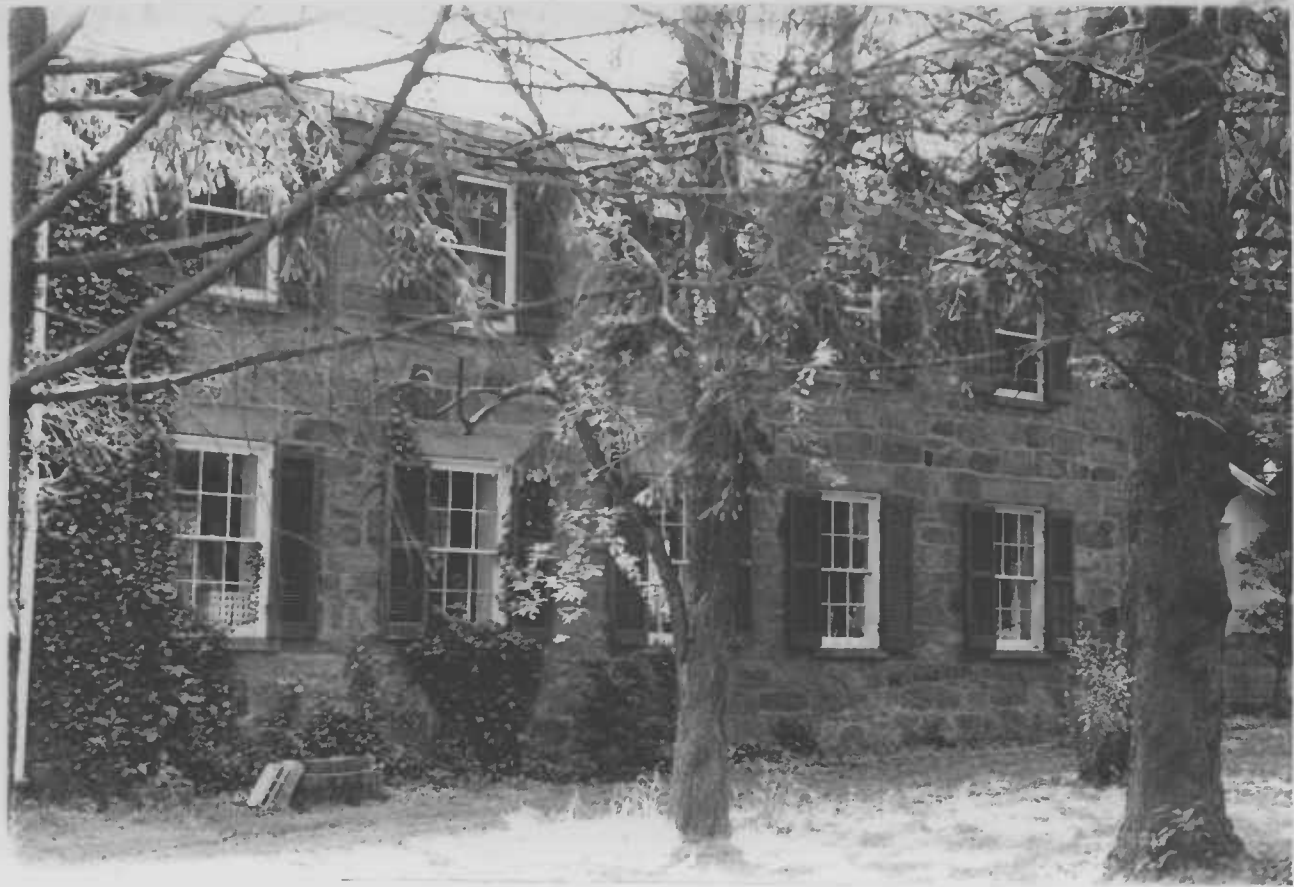
NAME ALLNUTT / WINDOLPH HOUSE  
16470 Darnestown Rd (MD28)  
LOCATION Rt 28 + 107 DAWSONVILLE MD  
FACADE W  
PHOTO TAKEN 5/17/74 MOWYER

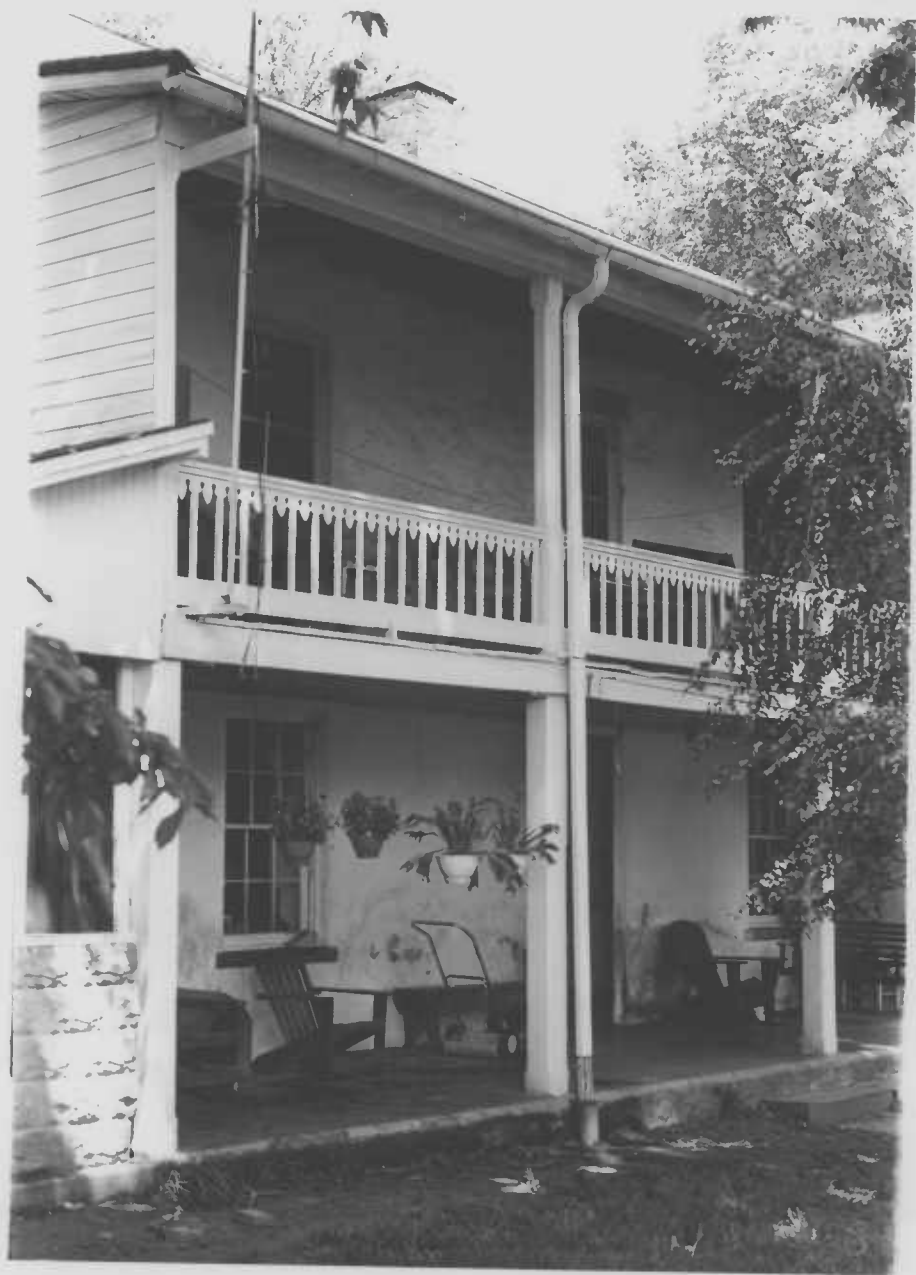
#18-23-2

NATH. ALLNUTT HOUSE

FACADE

S WING - SE FACADE

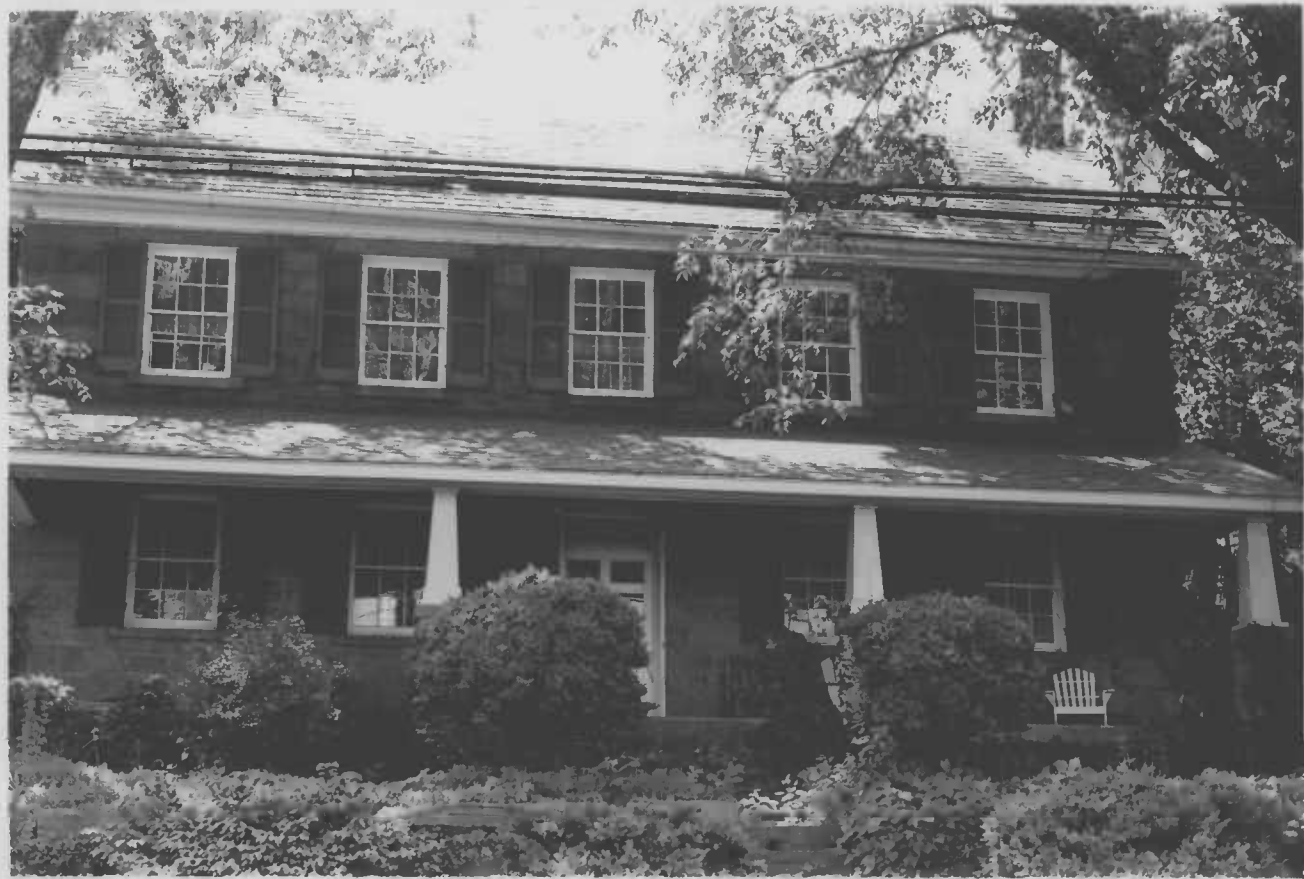
# 18-23-2

NAME ALLNUTT / WINDOLPH HOUSE

FACADE N

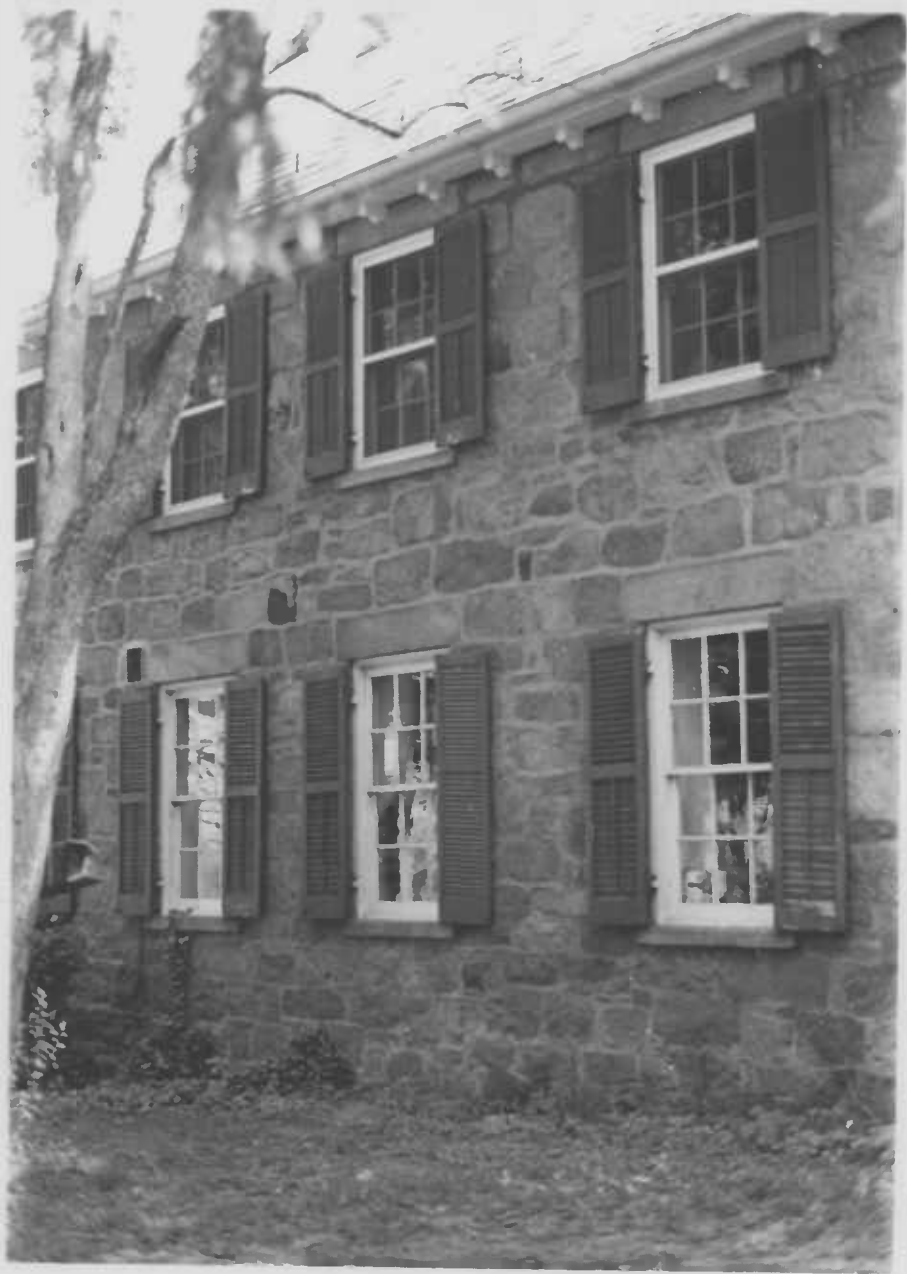
NAME NATH. ALLNUFF HOUSE #18-23<sup>2</sup>  
LOCATION 16420 Darnestown RD (MD 28)  
RT 107 + RT 28 DAWSONVILLE, Md  
FACADE S WING - W FACADE  
PHOTO TAKEN 5/17/74 MDWYER

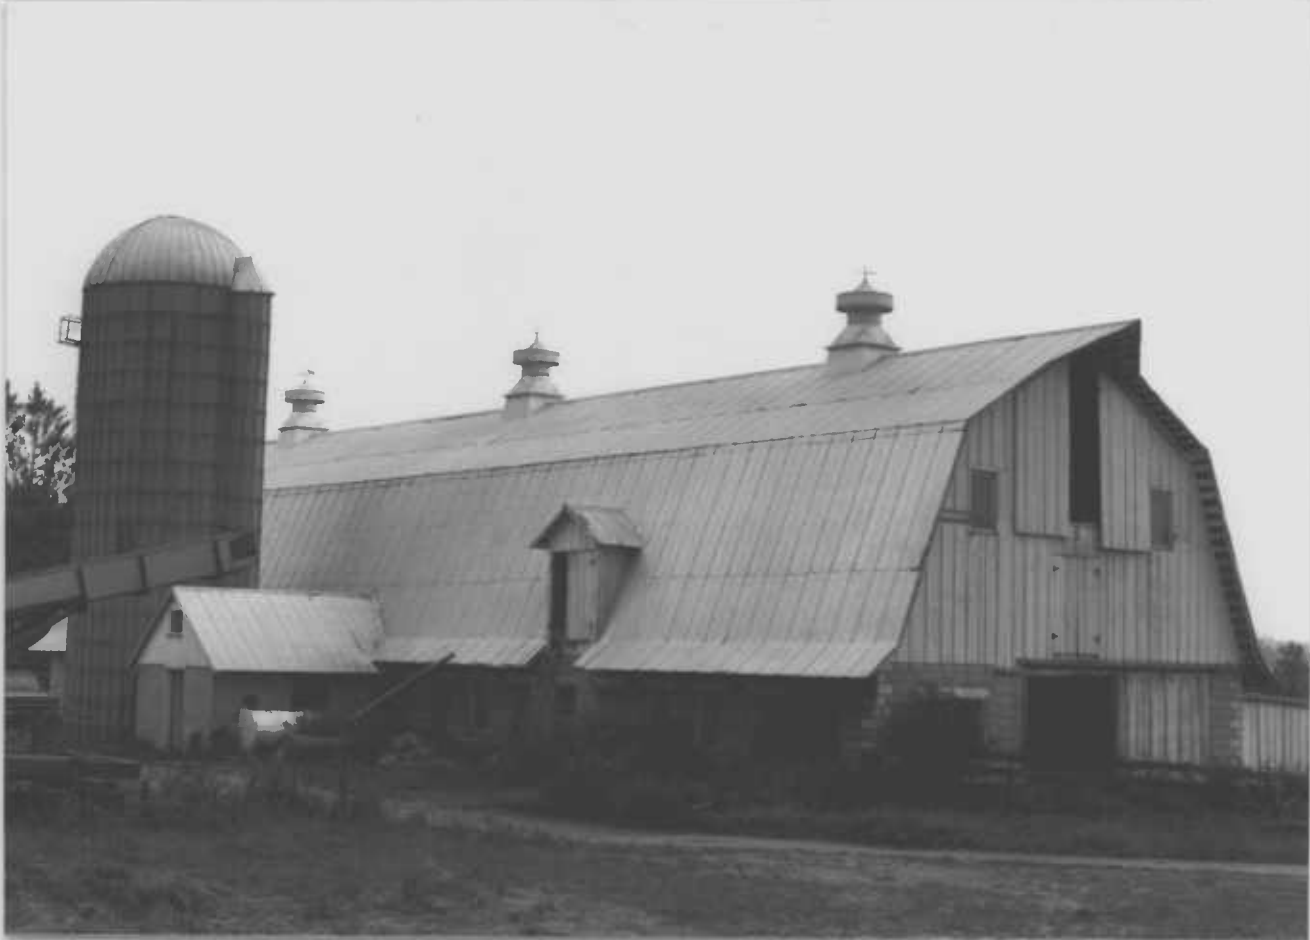
c. 1930 cow barn

The largest of these is the huge concrete block dairy barn. Twenty-one bays long, this barn is constructed of rock-faced concrete block, with smooth-faced white blocks used as quoins at the corners. The windows have white painted wood lintels. A small, gable roof, smooth-faced concrete block wing projects from the center of the west elevation. Two gabled dormers sheathed with vertical board-and-batten siding project from the roof. A Concrete stave silo with domed sheet metal roof stands just north of the wing. A small gable roof, smooth concrete block dairy stands at the north end of the east elevation. German siding covers the gable ends which contain a small, rectangular, louvered opening. A concrete block flue rises along the east wall of the dairy. A lean-to addition containing box stalls has been added to the east elevation. The north and south elevations are identical, each having at ground level a wide center doorway covered by a vertical board-and-batten rolling door. To each side of the doorway are pairs of windows containing 12-light wood sash. Above this, the gambrel ends are sheathed with vertical board-and-batten siding. Board-and-batten shutters cover a smaller opening beneath the large central opening into the hayloft. The doors for this opening, also vertical board-and-batten, roll diagonally up to close. On either side of these doors is a single window with 12-light sash. The gambrel roof is covered with sheet metal and has three large metal ventilators which sport weathervanes.

Looking northeast

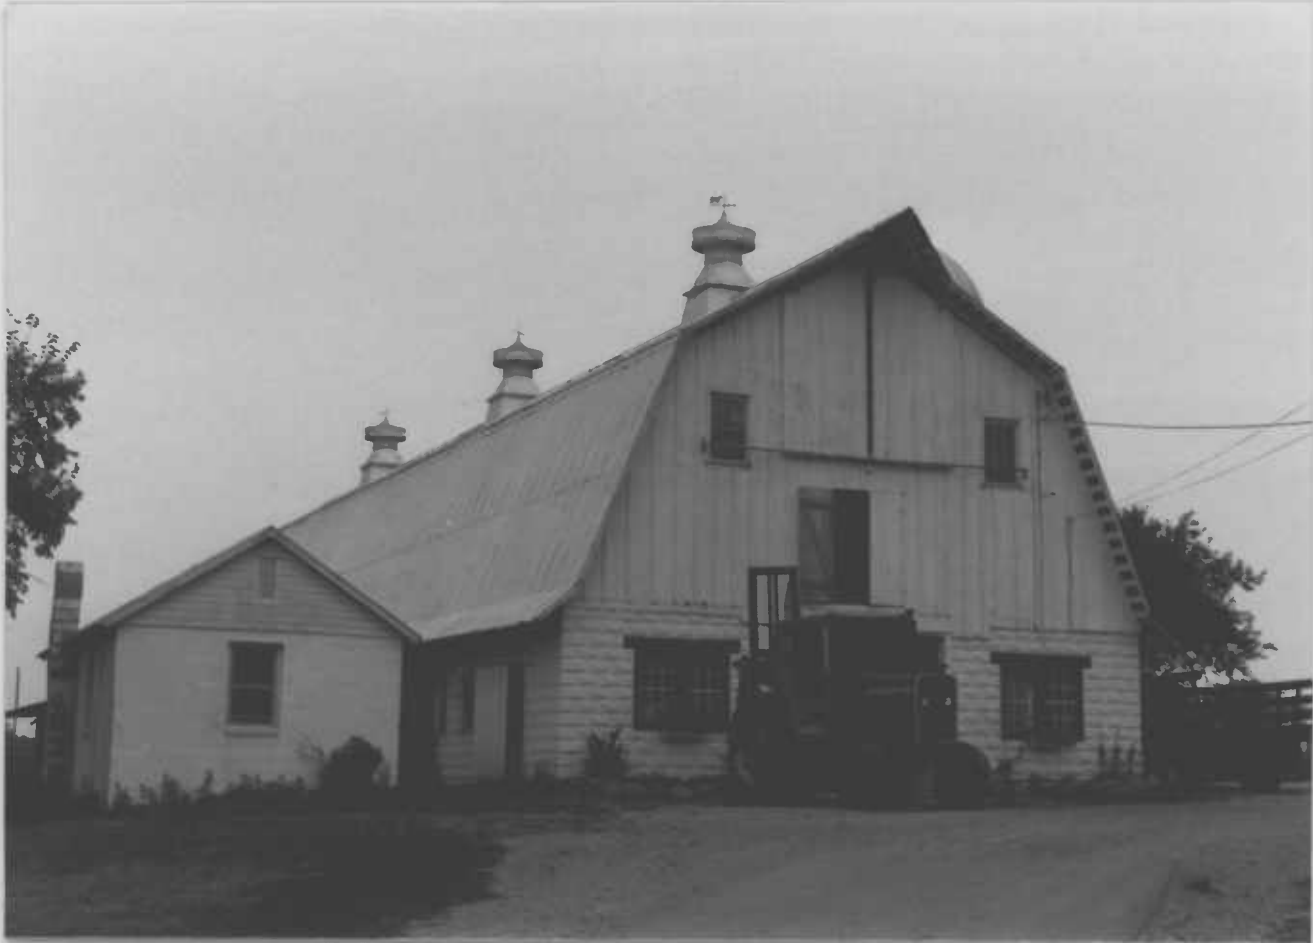
c. 1930 cow barn

North elevation

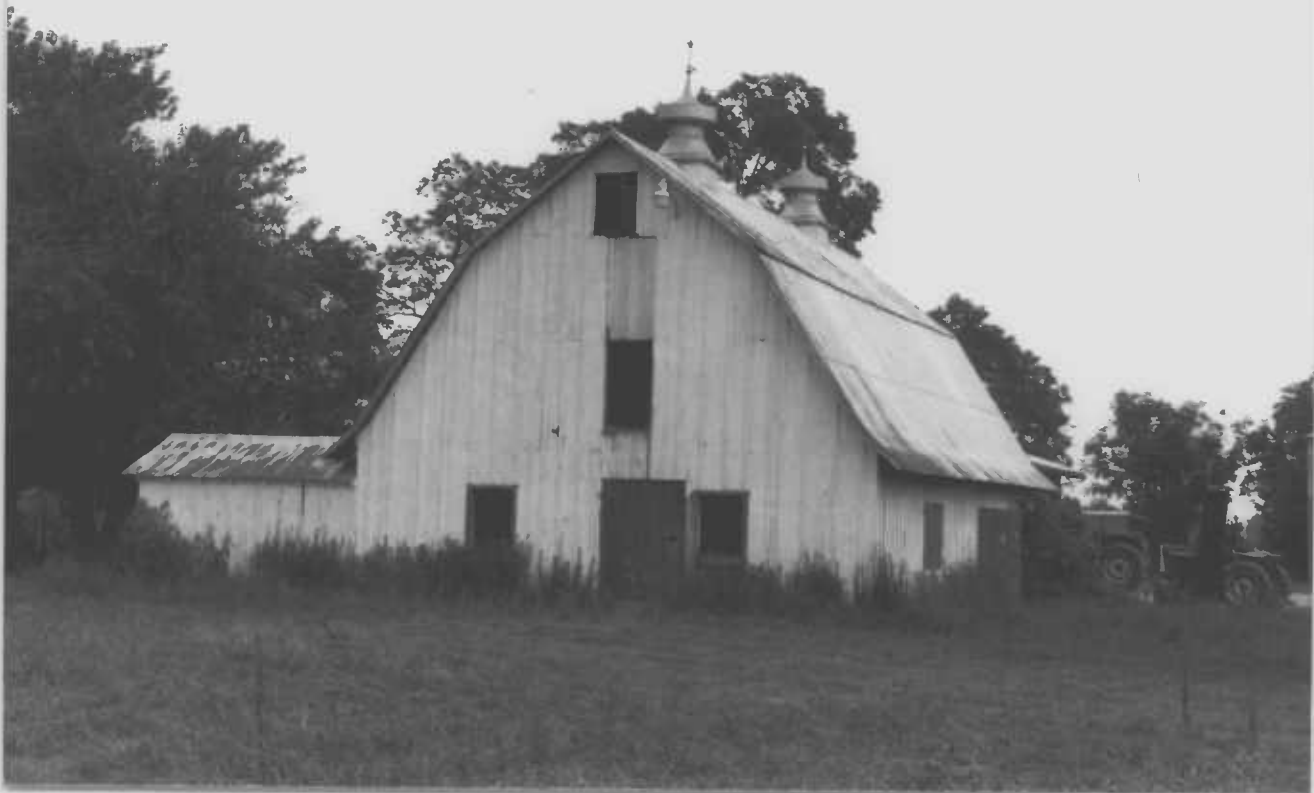
c. 1930 horse barn

The horse barn, built just after the dairy barn, is a wood frame, gambrel roof structure with vertical board-and-batten siding, resting on a foundation of rock-faced concrete blocks. The metal covered roof has two large sheet-metal ventilators topped with a spire and ball, and a weathervane with a five-pointed star at the tip. The north elevation has a small, central, board-and-batten door with a single window on either side. Halfway up the elevation is a small hinged wood door, and directly above that is a large opening with inward swinging double doors giving access to the hayloft. The east elevation contains three more board-and-batten doors, the north one being a dutch door. The south elevation contains a central door with a window on each side, a window opening halfway up the elevation, and a smaller opening at the peak of the gambrel. A one-story, gable roof wing projects from the southern end of the west elevation. Inside the barn has been altered by the removal of most of the box stalls. It is currently being used as a hog confinement barn.

South elevation

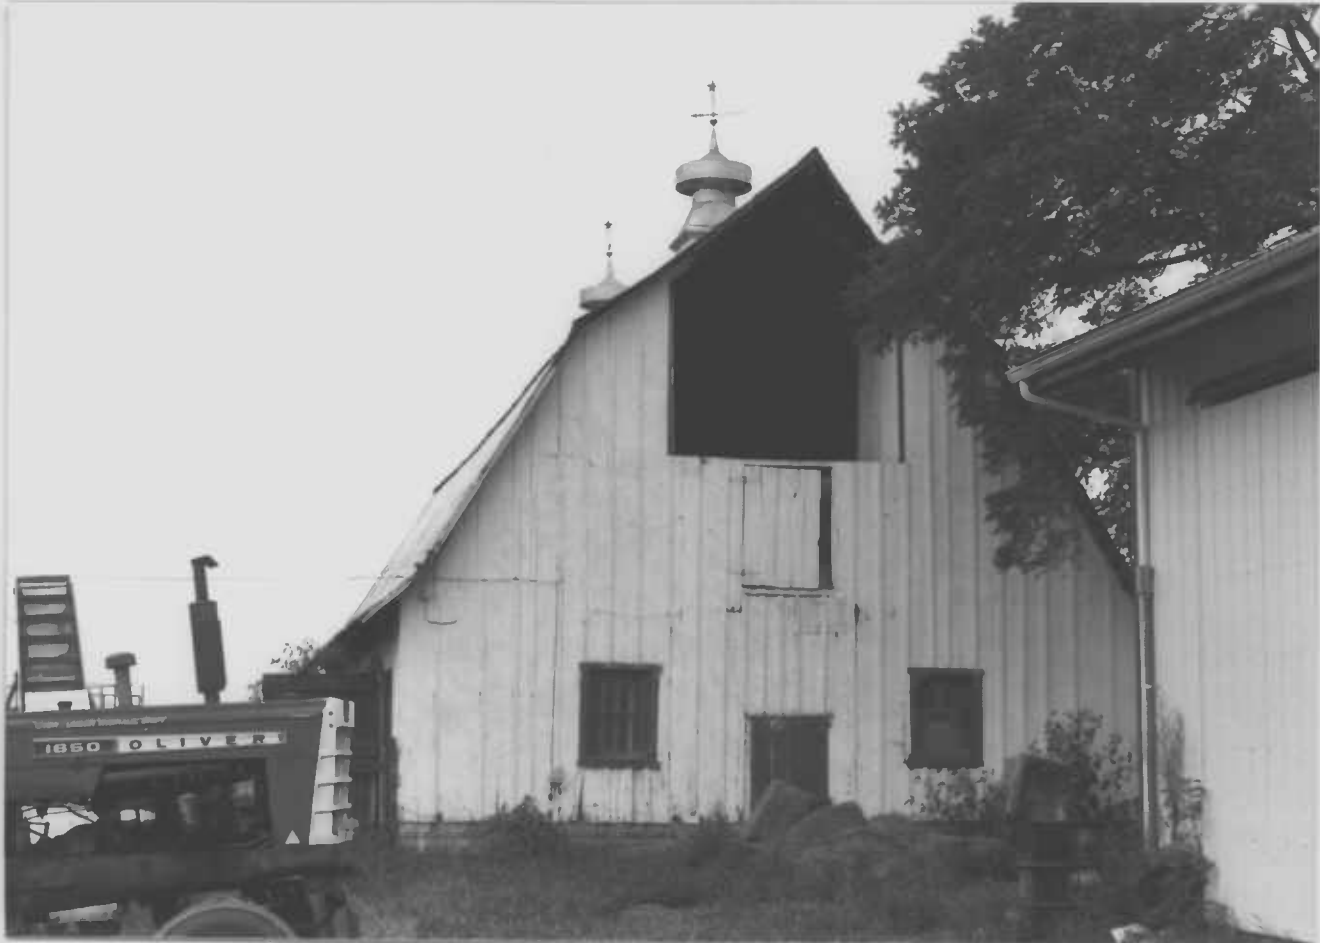
c. 1930 horse barn

North elevation

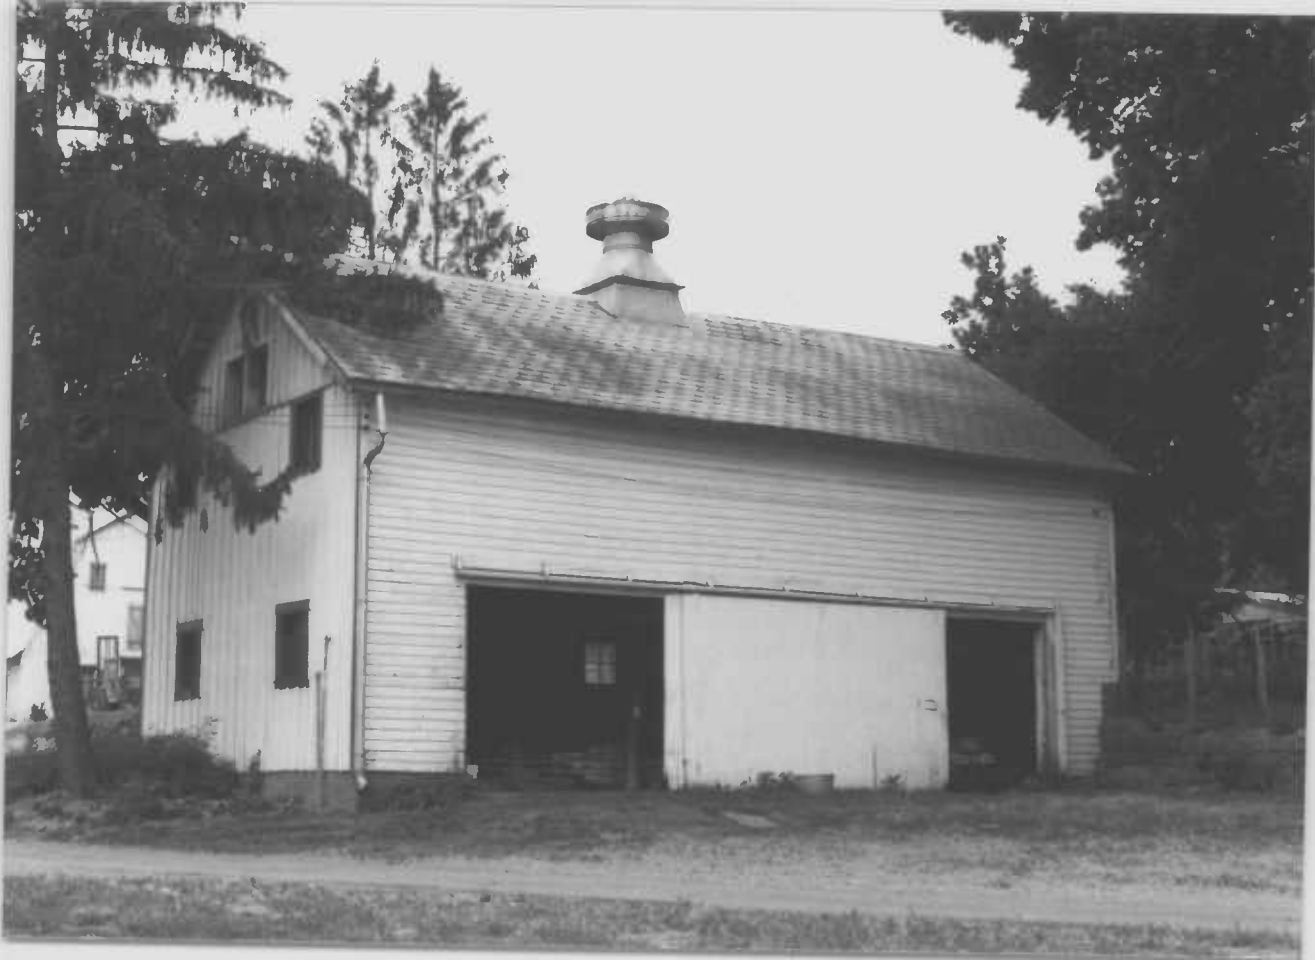
Grainery

The grainery, c. 1930, is a gable roof, heavy wood frame structure on a poured concrete foundation. The north elevation is sheathed in German siding and has wide, horizontally rolling wood doors covering the large opening spanning most of its length. The other three elevations are sheathed in vertical board-and-batten siding and have wood framed windows with trim painted green. The roof is covered with composition shingles and has a single, large, sheet metal ventilator in the center.

Looking southwest

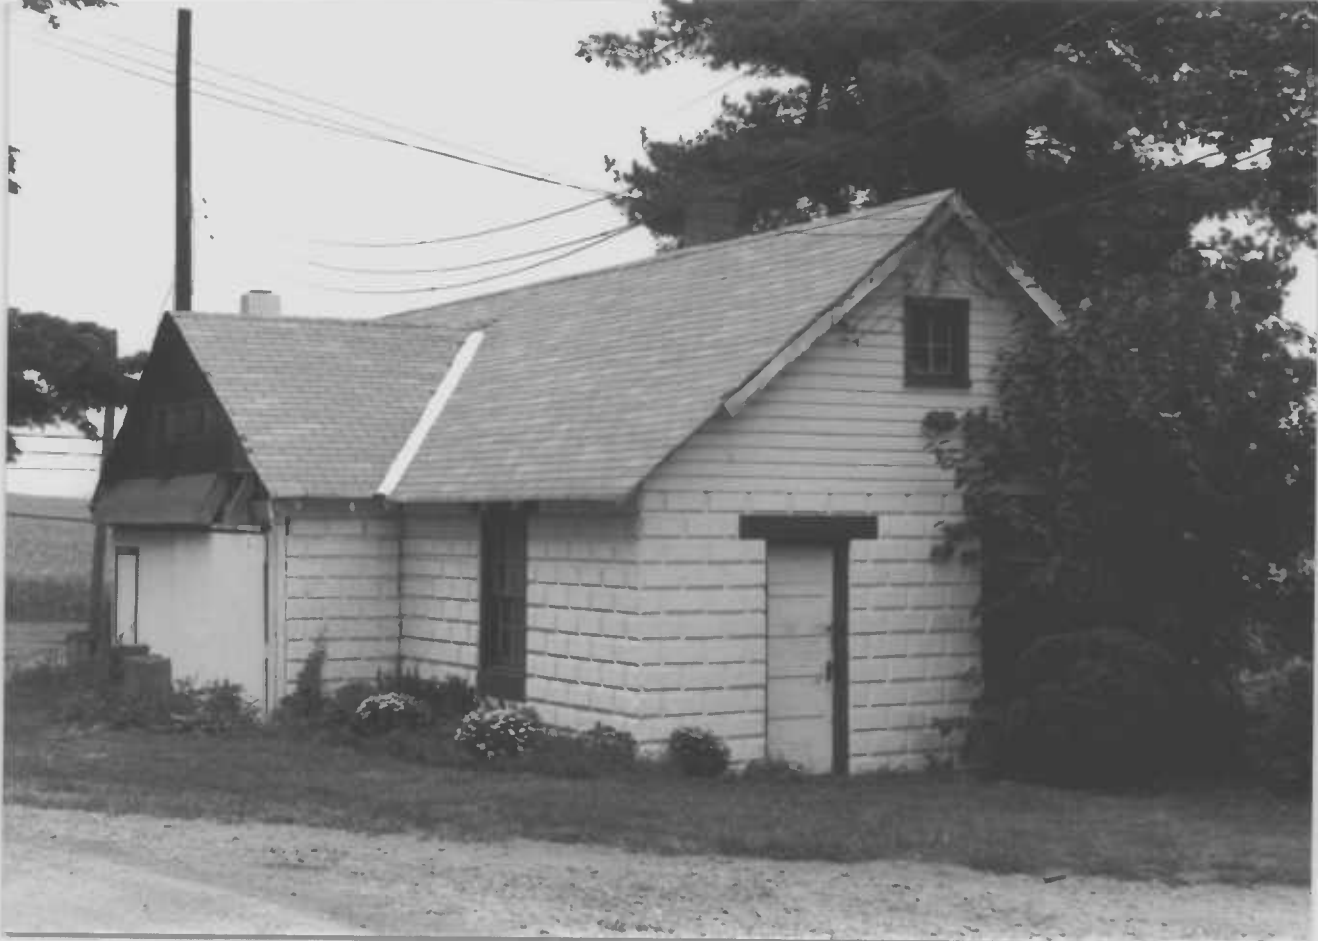
Tavern

The tavern building is of rusticated concrete block, now painted white. Its gable roof is covered with composition shingles and the gable ends are sheathed with German siding. A small four-light window near the peak of the gable lights the attic. The south elevation has a five-paneled wood door with wood lintel above, and a six-over-six, double-hung window, also with wood lintel. A similar window is in the west elevation, and a small gabled wing projects from this elevation.

Looking northeast
